ANALYSIS OF FAILED EX VIVO 36MM METAL-ON-METAL Pinnacle HIPS

TJ JOYCE*, JK LORD,
AVN NARGOL†, DJ LANGTON
Bioengineering Research Group

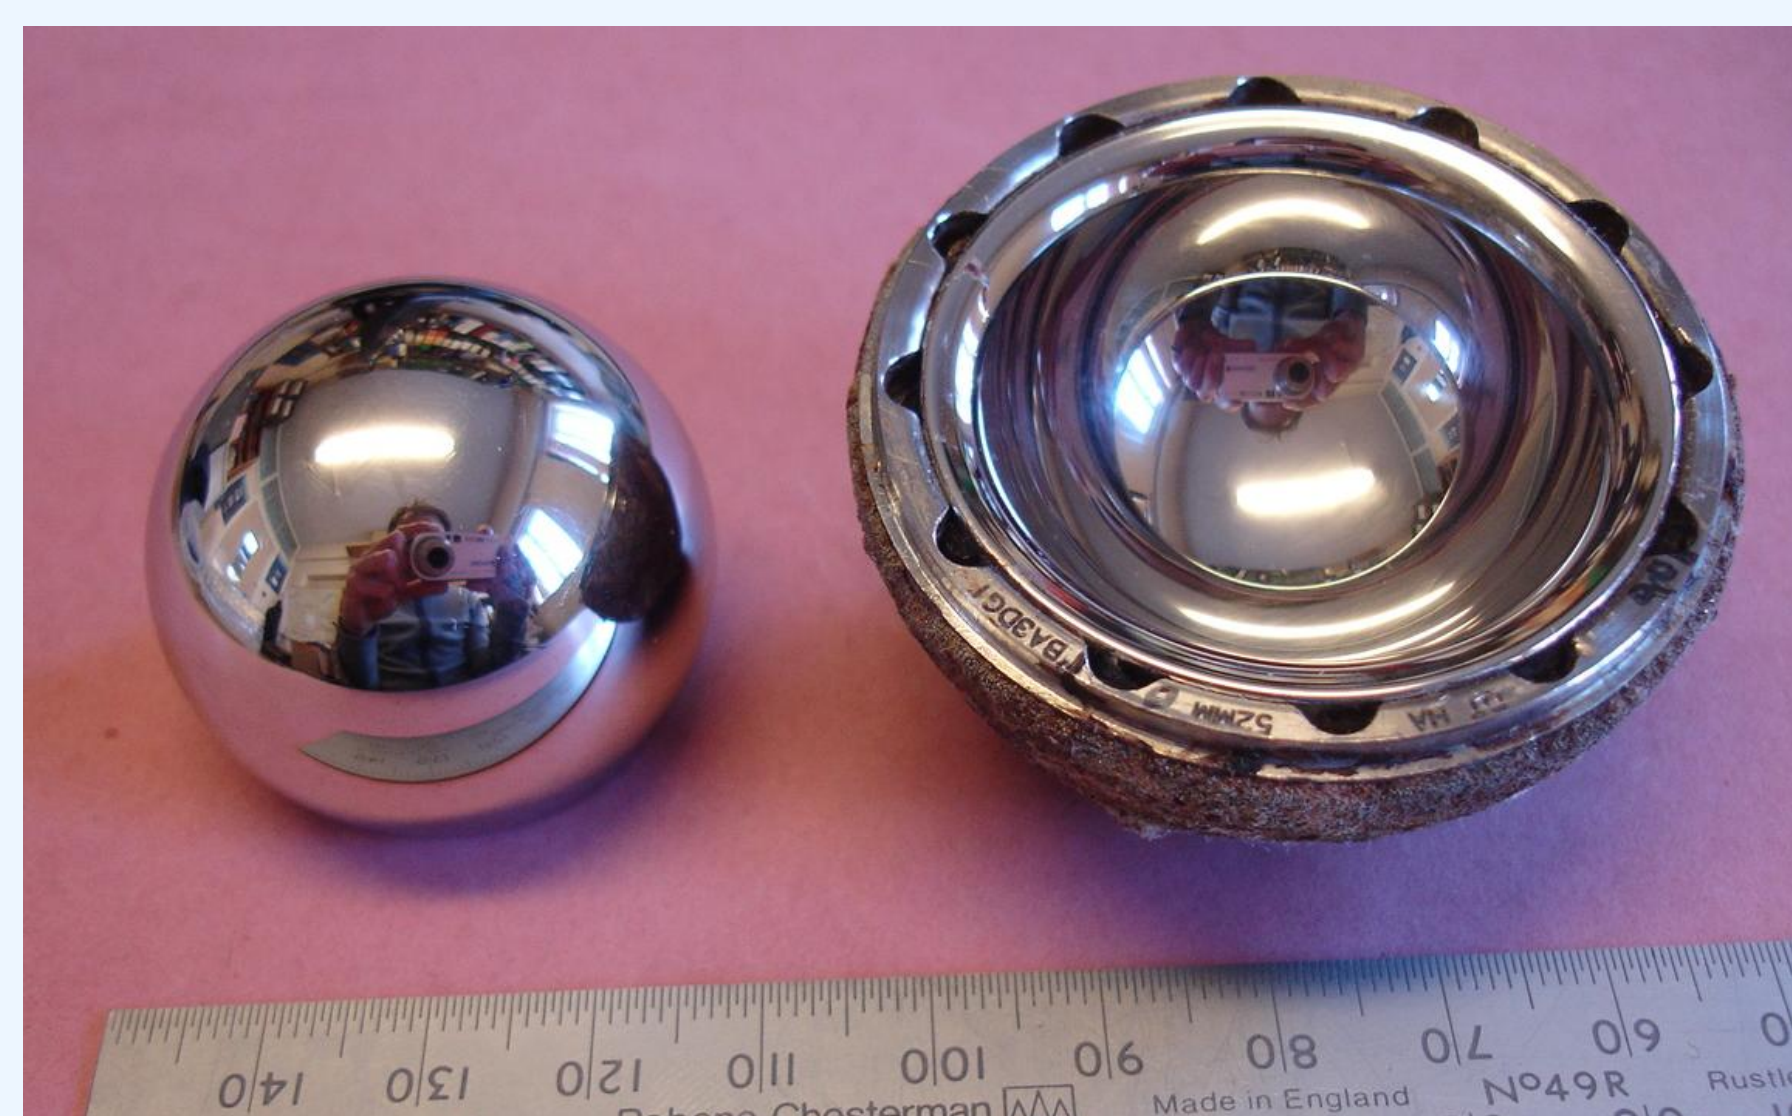
Figure 1: The femoral head (left) and acetabular cup (right) from an explanted 36mm MoM THR.

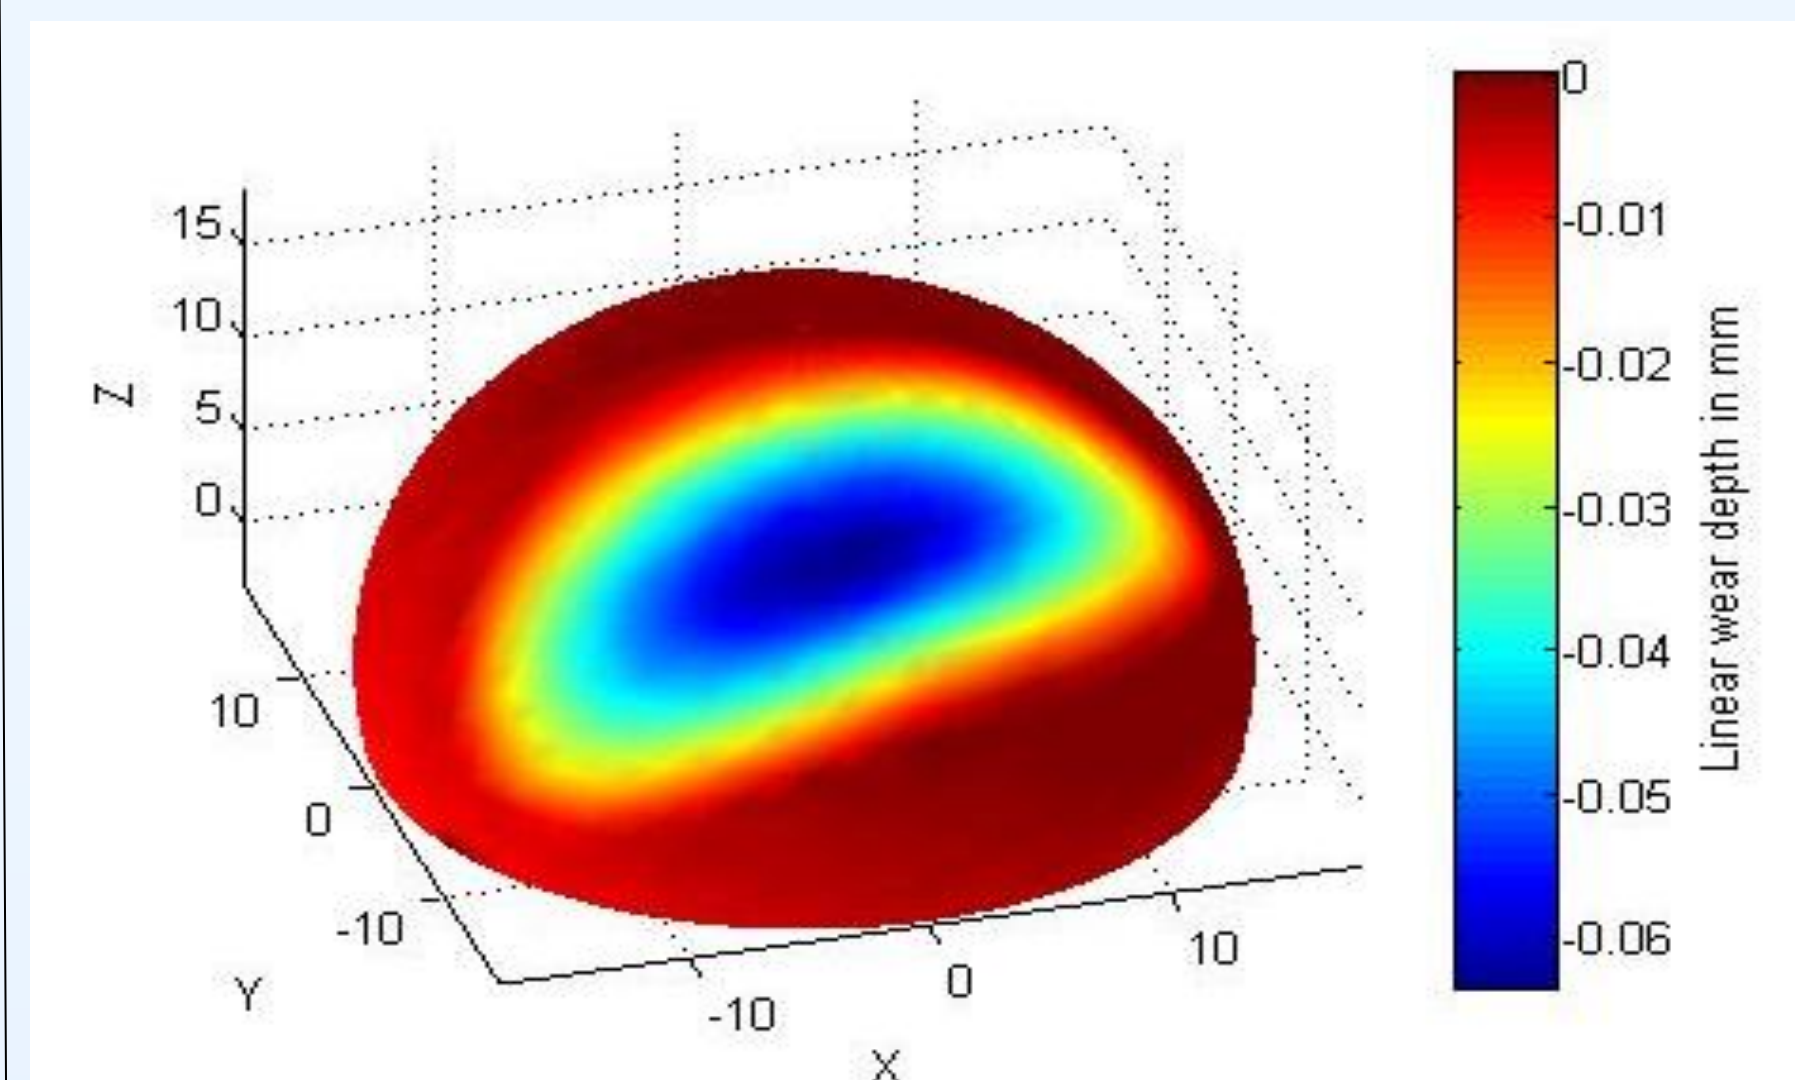
Figure 2: Image of most worn 36mm femoral head. Associated with high acetabular cup inclination (77°). Wear volume (dark blue) 18mm³.

From the articulating surfaces, a range of wear volumes per component were measured, from 1 to 18mm³ (figure 2). The paired head plus cup wear volumes ranged from 3 to 23mm³. Femoral head wear rates were usually greater than cup wear rates, means of 0.21mm³/month and 0.06mm³/month respectively being measured. Of the explants, 14 pairs were found to have low bearing surface wear rates of <3mm³/year (figure 3). In each of these cases, significant damage was identified at the internal taper junction of the femoral heads (figure 4). Roughness values of the articulating surfaces were typically in the range of 0.010 to 0.030µm Ra, so that the implants were operating under mixed lubrication. Articulating surface roughness measurements showed little increase over unworn areas. In total, 28 patients have been revised or listed for revision due to Adverse Reactions to Metal Debris (ARMD [5]). This represents an overall failure rate of 4.3% at mean 3.5yrs (range 1.8-5yrs). Blood Cobalt (Co) and Chromium (Cr) concentrations were generally low. Median cup inclination/ anteversion angles in the ARMD cases were 46° and 11°.

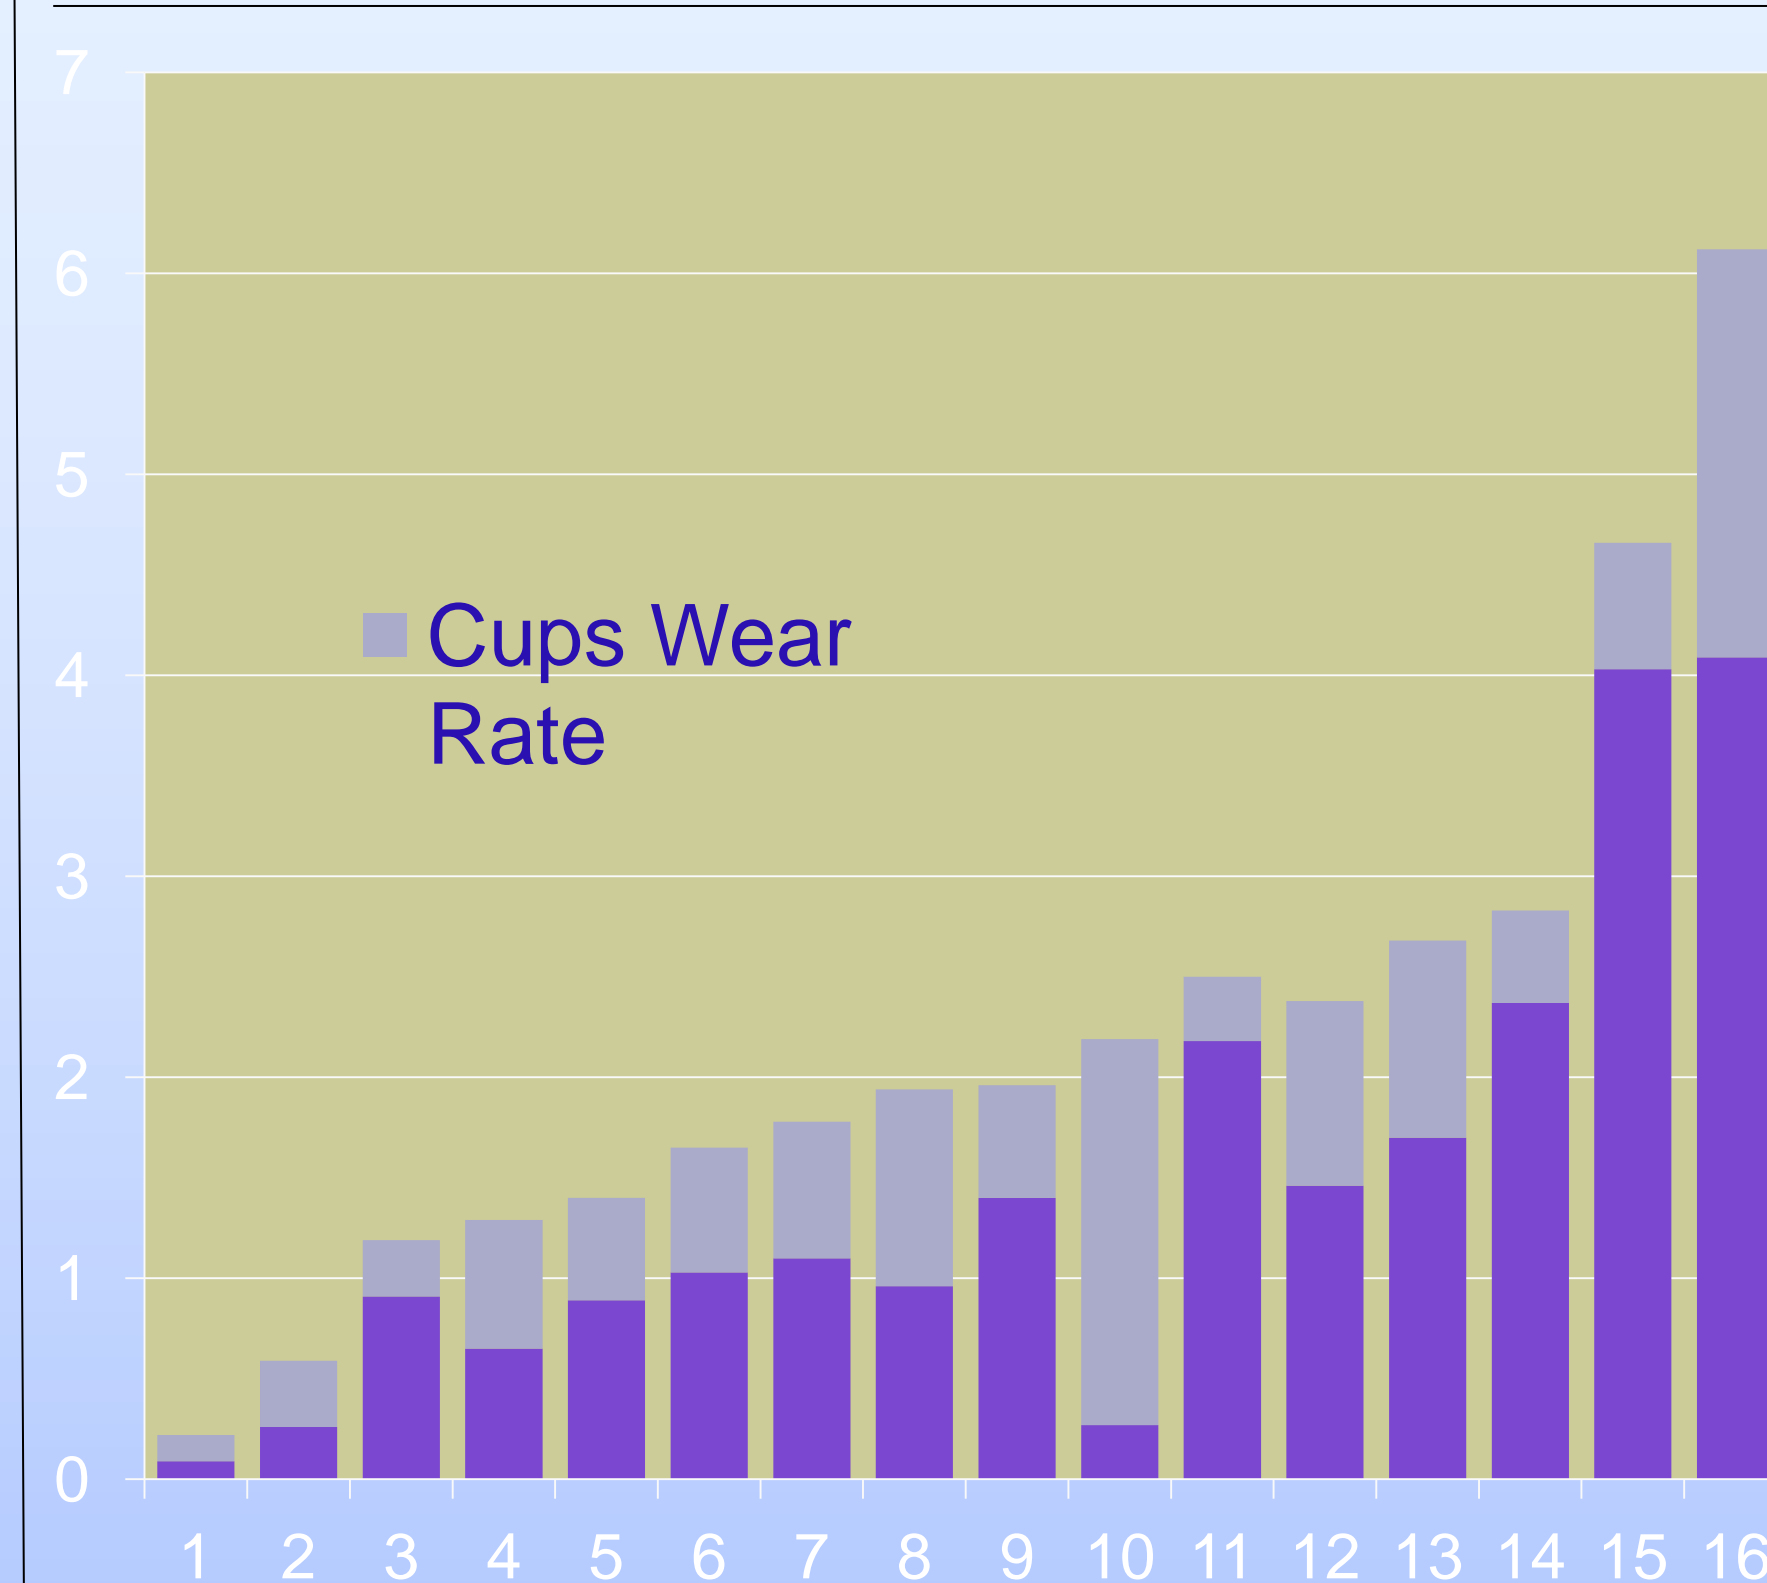
Figure 3: Wear rates (mm³/year) of 16 pairs of explanted MoM heads and cups.

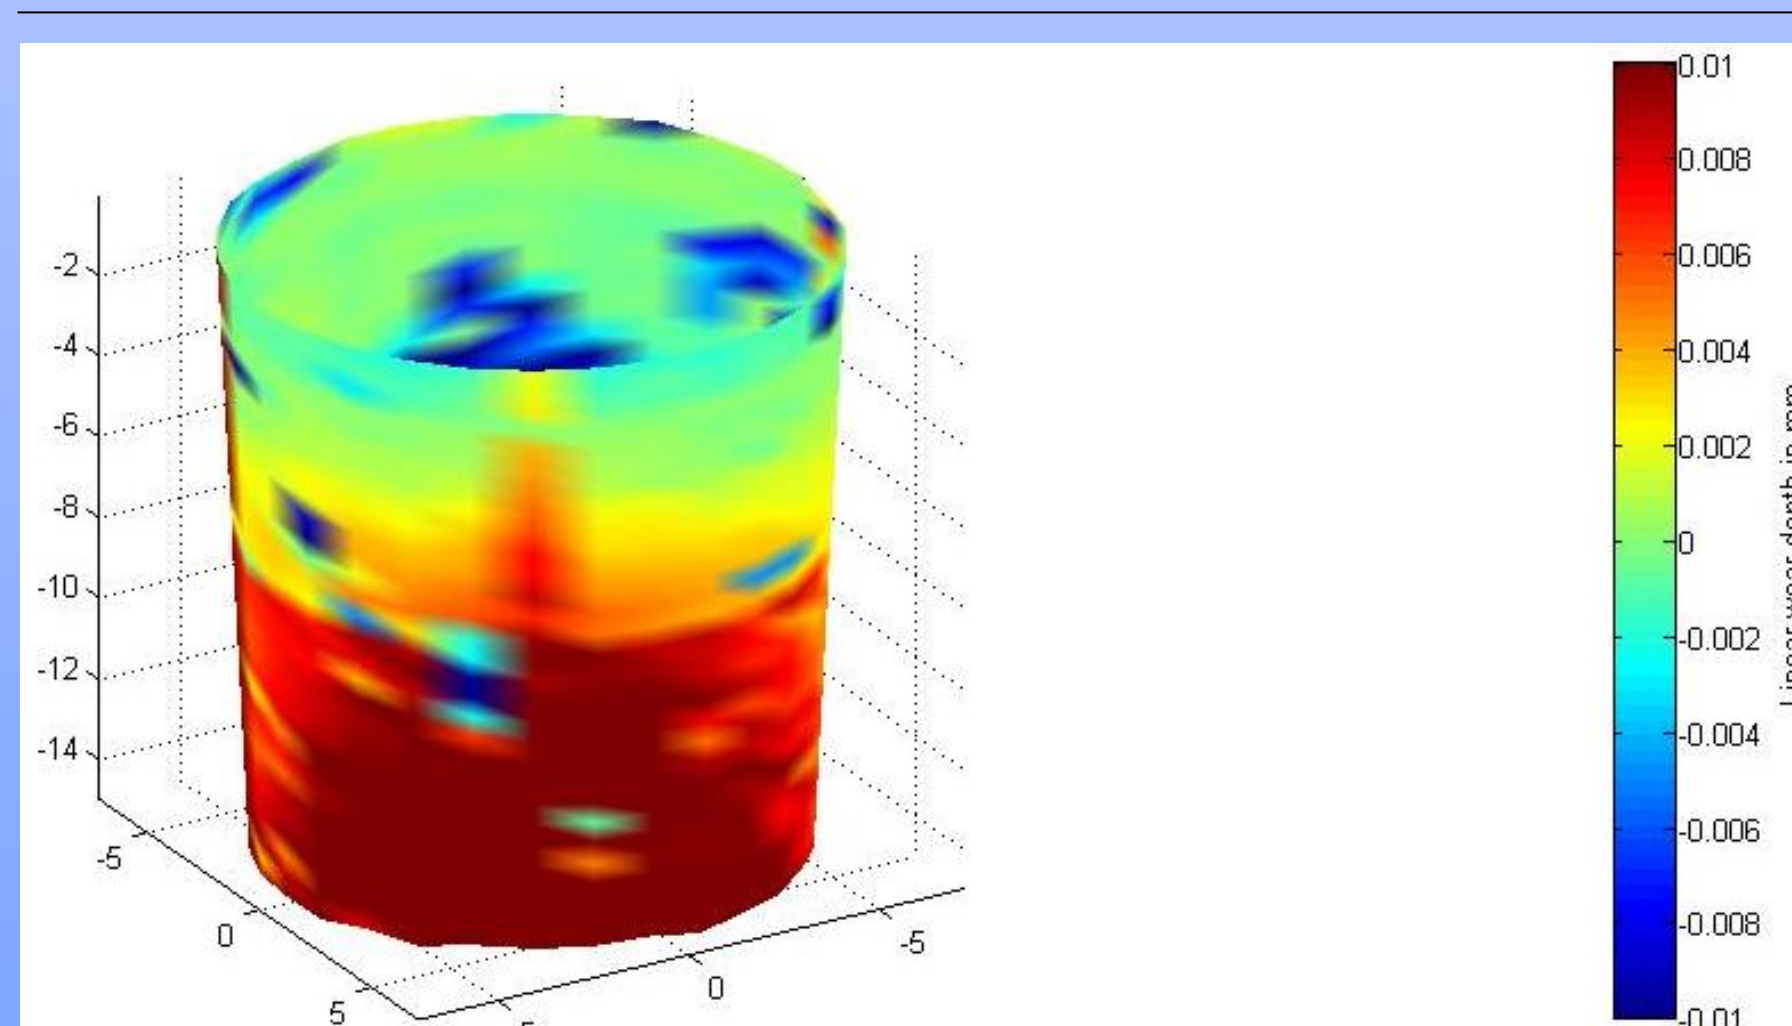
Figure 4: Taper damage from femoral head – 2.2mm³ wear volume (dark red), 19µm max wear depth.
