# Observations from the 26th November 2019 Albania earthquake: the earthquake engineering field investigation team (EEFIT) mission

Fabio Freddi<sup>1</sup> · Viviana Novelli<sup>2</sup> · Roberto Gentile<sup>1,3</sup> · Enes Veliu<sup>4</sup> · Stoyan Andreev<sup>5</sup> · Anton Andonov<sup>5</sup> · Federica Greco<sup>6</sup> · Emiljano Zhuleku<sup>7</sup>

## Abstract

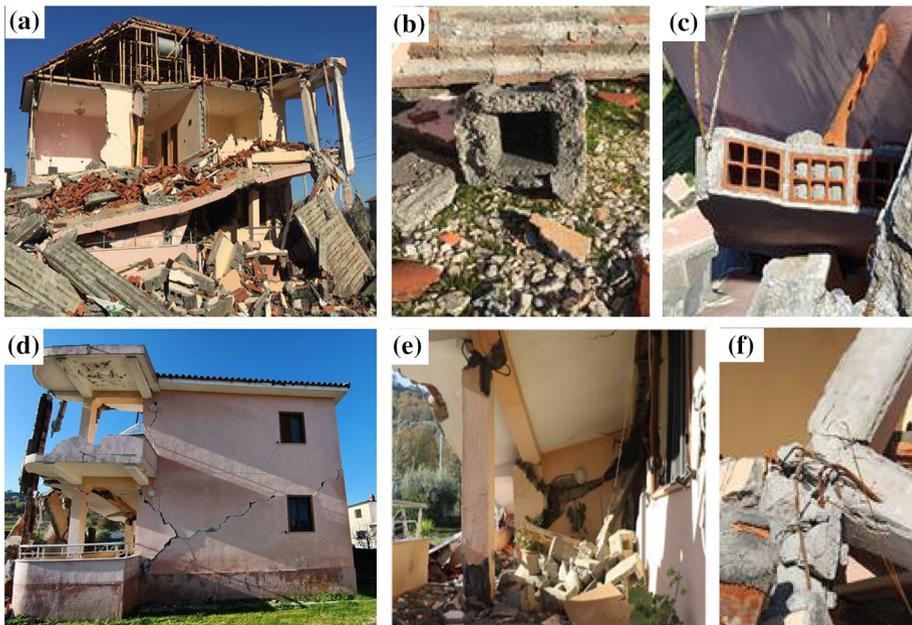
Similar failures and cracks were also observed in other single-family houses of the same typology with floor plans which differ in sizes. Local engineers confirmed that the 1st and the 2nd levels of these inspected houses were also built at different time, using different materials and structural floors for the 1st and 2nd level. Figure 10 shows the failure of a single-family house with a geometry plan smaller than the ones in Fig. 9. The observed

**Fig. 9** Single-family rural houses in Bubq. **a** Failure of the front part of the building due to the collapse of the portico porch, **b** hollow concrete blocks of the bearing walls, **c** detailing of the hollow core prefabricated concrete slab, **d** severe crack of the rear building's façade due to the failure of the portico porch, **e** internal view of the portico porch, **f** details of the joint failure due to poor smooth reinforcements, which are completely corroded

damage confirms that the failure is triggered by the joint failure of columns in the portico porch, as highlighted by the horizontal cracks on the top end of the 1st storey columns and overturning of the side façade.

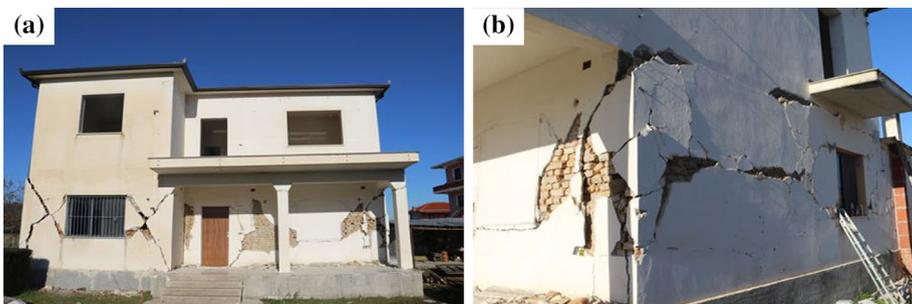
**Fig. 10** Single-family rural house in Bubq. **a** Shear damage highlighted by the presence of diagonal cracks at the first level, **b** overturning of the rear façade of the building

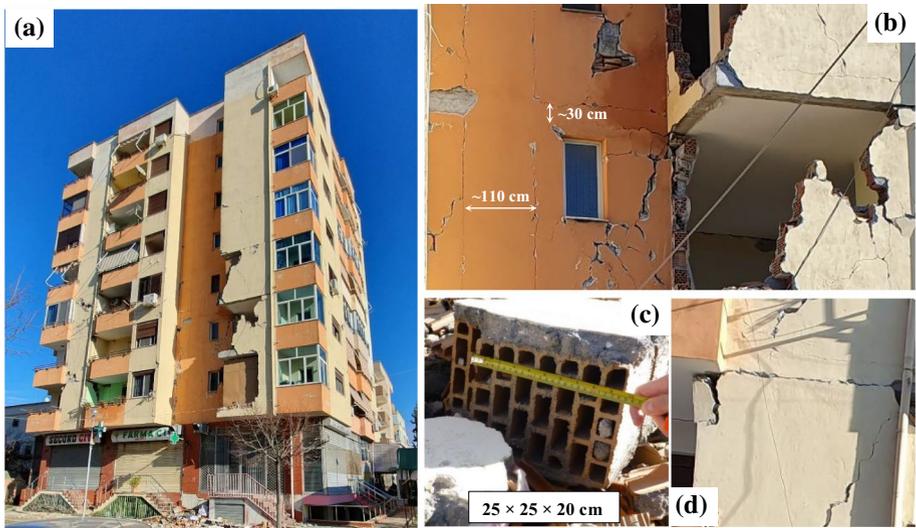
The structure is characterised by internal and external columns with large dimensions approximately equal to  $80 \times 80$  cm and  $110 \times 35$  cm, respectively. The dimensions of the external column can be observed in Fig. 12b, due to the formation of the vertical cracks in the plaster. Figure 12b shows also the cracks corresponding to the position of the beams which have a depth equal to the thickness of the floor slab (approximately 30 cm). This structural configuration of strong columns-weak beams is most probably the outcome of low design accelerations and lack of stiffness requirements.

The infilled panels are made by large hollow bricks ( $25 \times 25 \times 20$  cm), with horizontal holes as shown in Fig. 12c. The interaction of the flexible structure with the stiff infills led to significant non-structural damage. In fact, infill panels in these structures are often characterised by shear cracks. Moreover, some of the unconfined panels have collapsed (Fig. 12b), or experienced heavy damage. In addition, as shown in Fig. 12d, the damage

**Fig. 12** Typical 2000s multi-storey reinforced concrete (RC) building compliant with KTP-N.2-89. **a** Building overview and extended damage, **b** cracks in the plaster and identification of beams and columns, **c** dimension of the hollow bricks of the infill panels, **d** detachment of the infill panel and formation of horizontal cracks

pattern is also characterised by horizontal cracks at floor level in the lower side of the floor slabs. This is related to the lack of construction detailing and a poor connection between the top side of the infill panels and floor slabs. This configuration promotes the detachment of the infills from the beams and this damage pattern is distributed over the first five storeys of the building. Figure 13 shows a closeup of the damage pattern of the eastern façade of the building which highlights the significant vulnerability of this type of stiff infill panels, especially when unconfined.

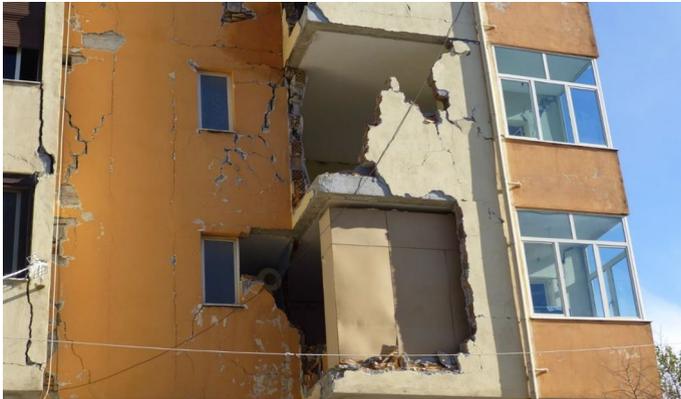
**Fig. 13** Typical 2000s multi-storey reinforced concrete (RC) building compliant with KTP-N.2-89. Damage layout in the eastern façade of the building

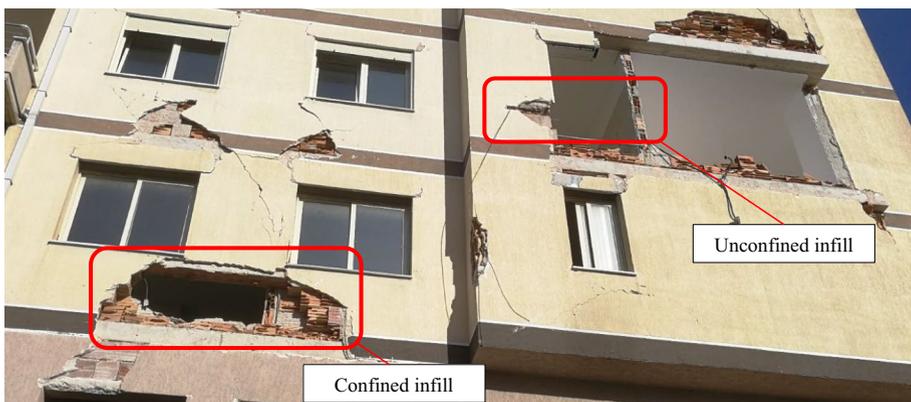
confinement significantly affected the seismic response of the non-structural components, leading to shear cracks but also to out-of-plane failure of the infills. This is also highlighted in Fig. 14, showing how the belt beams for the infills are ineffective when used in unconfined frames. It is worth mentioning that many buildings with similar characteristics showed the same damage pattern.

**Fig. 14** Typical 2010+ multi-storey reinforced concrete (RC) building compliant with KTP-N.2-89 with integration based on the Eurocode 8. Effects of the belt beams in confined and unconfined infills

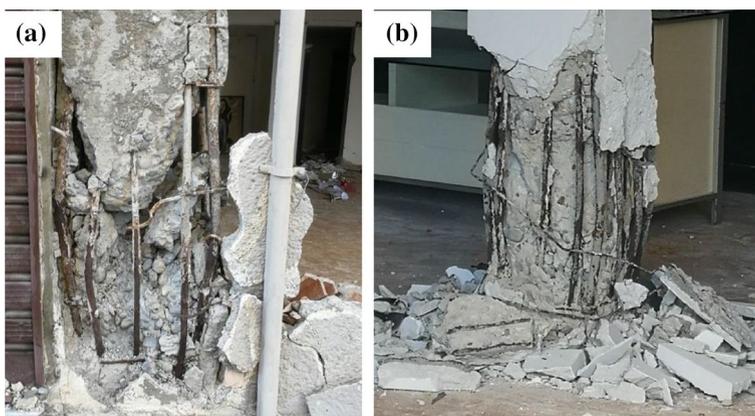
**Fig. 15** Case with structural damage showing shear and axial failure in **a** external column; **b** internal column

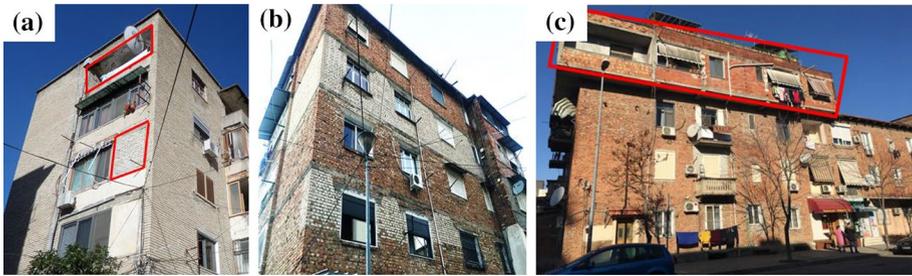
The major deficiencies observed for these buildings are related to irregularities in elevations due to unauthorised interventions such as the closure and creation of new openings, use of different masonry for reparation, and introduction of additional floors carried out by the owners of the single dwellings as showed respectively in Fig. 19a–c. These alterations, together with the lack of maintenance, degradation of the mechanical properties of the material, and change of the load paths, can become the origin of damage and deteriorations, which may increase the seismic vulnerability of the structure over its lifetime.

**Fig. 19** Unauthorised interventions on unreinforced masonry (URM) buildings in Durrës. **a** Irregularities in the opening layout due the closure of part of the balcony; **b** use of different construction materials and **c** presence of an additional floor

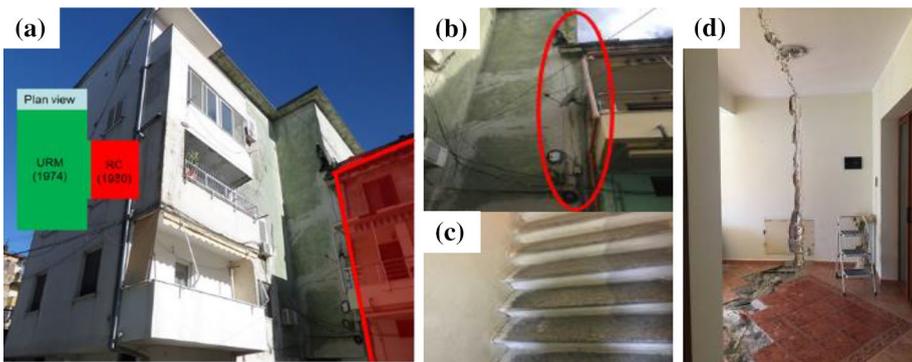
URM buildings made of silicate bricks with hollow core prefabricated concrete slabs were also inspected in the city of Lezhë, located in the northwest of Albania, about 50 km from the epicentre. In this area, only a few buildings were (red) tagged as unsafe by local engineers, although the damage consisted of non-structural damage on external bearing walls and light shear diagonal and X-shape cracks on internal bearing walls.

**Fig. 20** **a** 5-storey pre-1990 unreinforced masonry (URM) buildings made of silicate bricks and hollow core precast concrete slabs, inspected in Lezhë, **b** pounding damage between the URM building and reinforced concrete (RC) building, **c** detachment of the staircase, and **d** gap opening

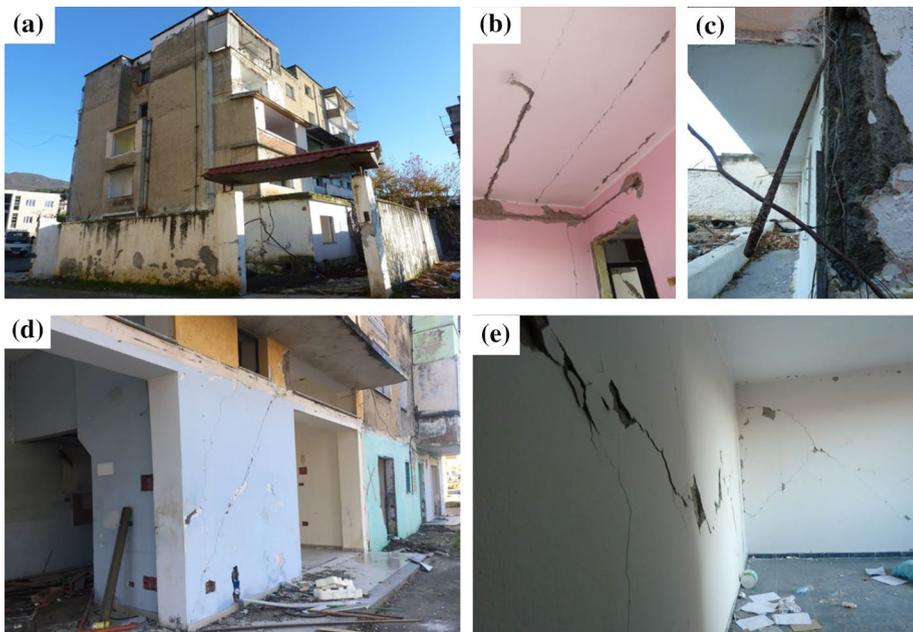
A similar seismic performance was also noted for a few CM buildings with silicate bricks and with hollow core prefabricated concrete slabs inspected in Laç (see Fig. 1).

**Fig. 21** **a** 5-storey pre-1990 concrete-masonry (CM) building made of silicate bricks and hollow core precast concrete slabs, inspected in Laç, **b** horizontal cracks due to the displacements of the prefabricated panels of the precast concrete slabs **c** yielding of corroded and exposed reinforcements in the column, **d** large openings at the ground level failing for shear highlighted by the presence of diagonal cracks, **e** internal load bearing walls failing for shear highlighted by the presence of diagonal cracks

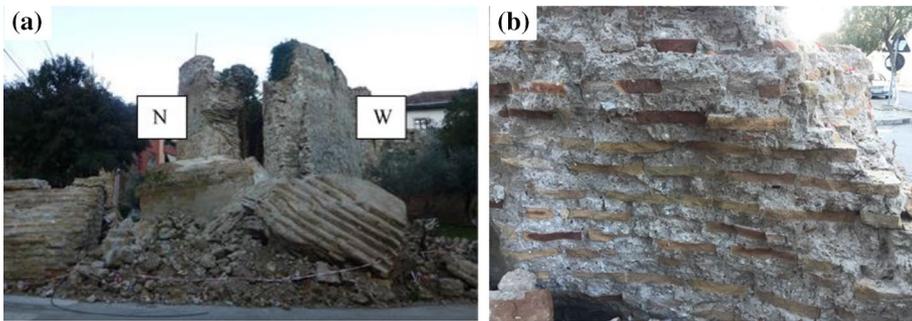
**Fig. 23** **a** View of the gate tower after the November earthquake; **b** close view of the collapsed masonry in Durrës

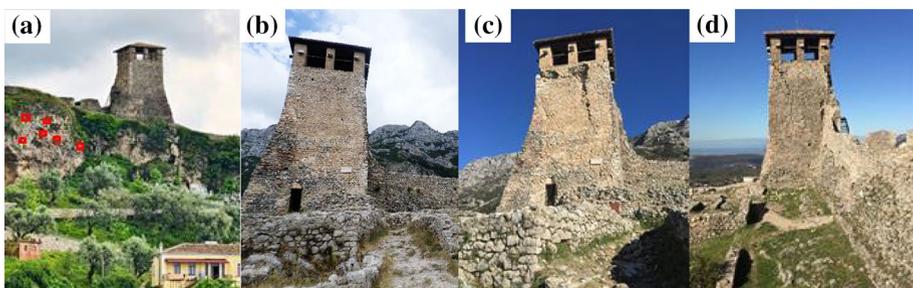
The clock tower is an unreinforced stone masonry structure dating from the twelfth century, with a quasi-pyramidal shape at the bottom and a squared geometry at the top. Access to the tower is understood to be on the front and rear sides from two doors located at different levels, connected through a timber staircase allowing the entry to the top floor. The clock tower underwent a series of interventions: the first intervention took place in the 1920–1930s and consisted on the reconstruction of the masonry of the tower in its middle part; a second intervention took place in the 1970s to reconstruct the top of the tower and included the introduction of a RC rigid floor, possibly with concrete ring beams, and columns with tuff cladding supporting the timber roof. The November earthquake caused the

**Fig. 24** Krujë clock tower. **a** The locations of the anchors on the hill's side near the clock tower are highlighted in red (<https://goaslocal.com/tour-category/culture-heritage-tours/>), **b** Front view before the earthquake ([https://commons.wikimedia.org/wiki/File:Krujë\\_Watchtower\\_and\\_Castle\\_Walls.jpg](https://commons.wikimedia.org/wiki/File:Krujë_Watchtower_and_Castle_Walls.jpg)), **c** front view, and **d** rear view after the November earthquake in 2019

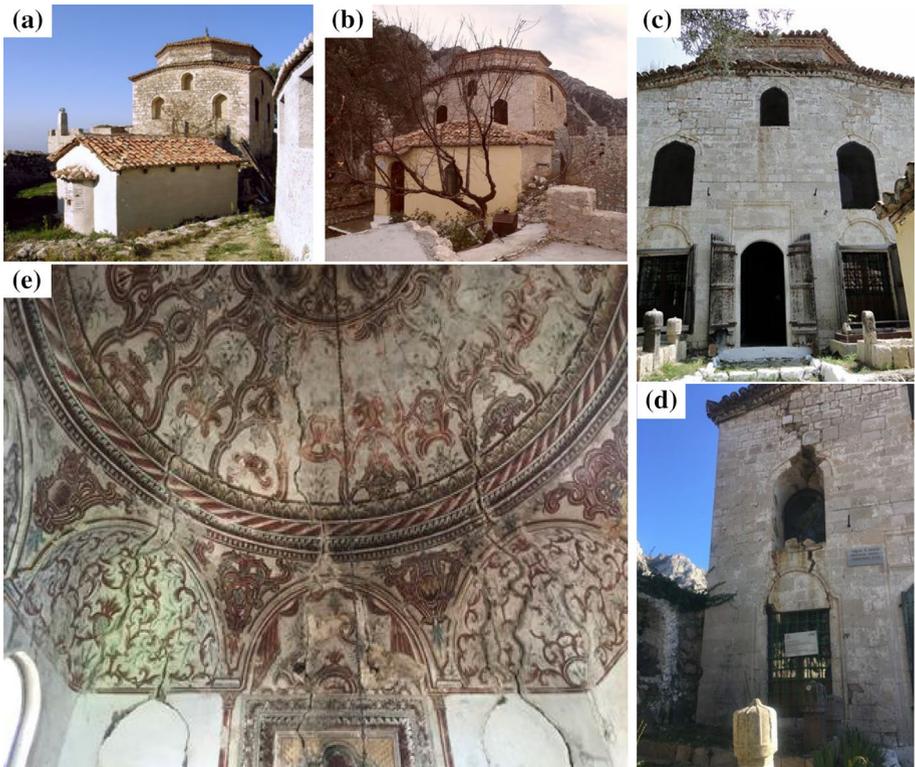
On the other side of the castle, another building was found in extremely poor condition at the time of the survey. This is the Tekke of Dollma, shown in Fig. 25, which is a religious construction dated back to 1789 and proclaimed Monument of Culture in 1973 (IRPP/SAAH 2006). The building's square shape turns into hexagonal in the upper part to envelope the central dome. The dome is sitting on squinches which are in turn resting on the stone masonry walls. Figure 25a–c show the front and rear view before the earthquake, while Fig. 25d, e show the situation after the November earthquake.

**Fig. 25** Tekke of Dollma. **a** Front view ([https://en.wikipedia.org/wiki/Dollma\\_Tekke](https://en.wikipedia.org/wiki/Dollma_Tekke)), **b** rear view (<https://mapio.net/pic/p-63037109>), **c** view of the front view before the November earthquake 2019 (<http://www.visionsoftravel.org/Kruj%C3%A9-dollma-teqe-albania/>), **d** close view of the extended crack due the November earthquake 2019 and **e** internal view of the cracking observed in Tekke of Dollma dome

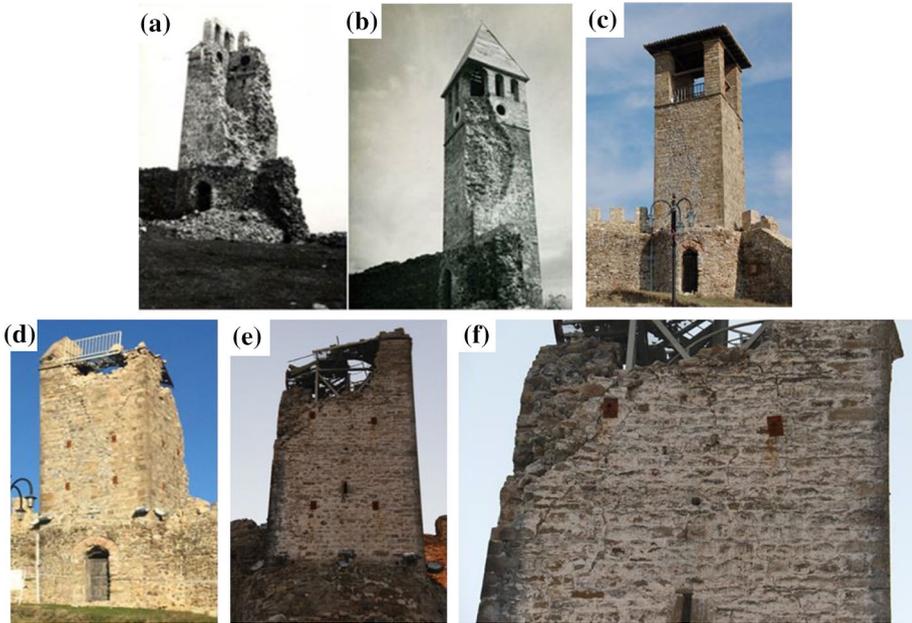
**Fig. 26** Prezë clock tower **a** and **b** damage suffered in past earthquakes (Mustafaraj and Yardim 2014). Front side **c** before and **d** after the 2019 November earthquake. **e** South side and **f** close up of the south side after the 2019 November earthquake

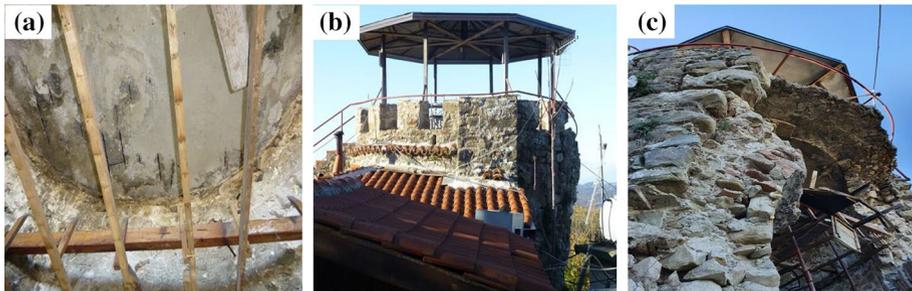
The North tower in Fig. 27 was also damaged by the November earthquake. This tower has a circular shape and is made of stone masonry walls. Visible alteration to the original configuration of the tower observed during the visit are the introduction of a RC floor to create a terrace on the roof of the tower (Fig. 27a) and the construction of a building on the side of the fortification walls and adjacent to one of the sides of the tower (Fig. 27b). The damage occurred on the outer side of the tower, facing the cliff. This side is the most vulnerable due to the lack of confinement provided by adjacent structures. In this part, the masonry collapsed for out of plane mechanism, whereas the stiff slab remained undamaged

**Fig. 27** View of the Prezë north tower and alteration to the original configuration: **a** new reinforced concrete (RC) slab, **b** new construction adjacent to the side of the tower and **c** view of the damage to the Prezë clock tower
