Thermal Effect of Bone Reaming

MEng Mechanical Engineering with Bioengineering
behrokh.eskandari@newcastle.ac.uk
 School of Mechanical and Systems Engineering

Acetabular reaming in Total Hip Arthroplasty measured with the aid of an Infrared Thermal Camera

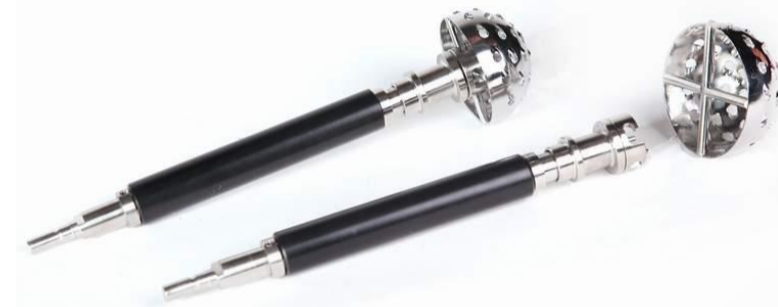
Figure 1 – Typical reamer and handle

Total hip replacement surgery is common in modern medicine and it provides patients with pain free gait. During surgery, high speed mechanical tools such as reamers (Figure 1) are used to prepare bone to receive the implant. Acetabular reamers are used to create the required part-spherical cavity in the acetabulum for the artificial cup or shell of a total hip replacement.

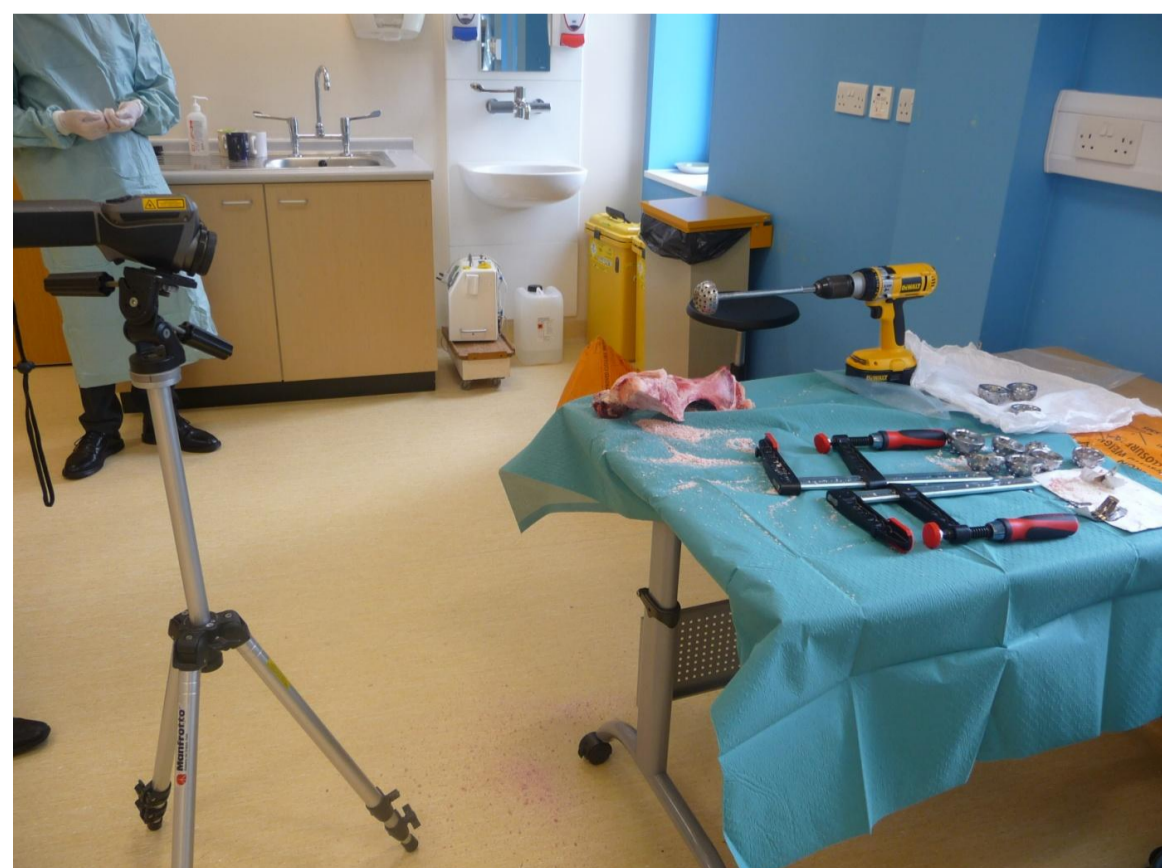
Figure 2 - Hemi-pelvis and FLIR E45 camera position during testing. Note reamer on the end of the drill and some debris from reaming process

Reaming process was performed on 8 bovine acetabula (hemi-pelvis) using various reamers while the temperature was recorded. All reamers were used and several different sizes were tested.

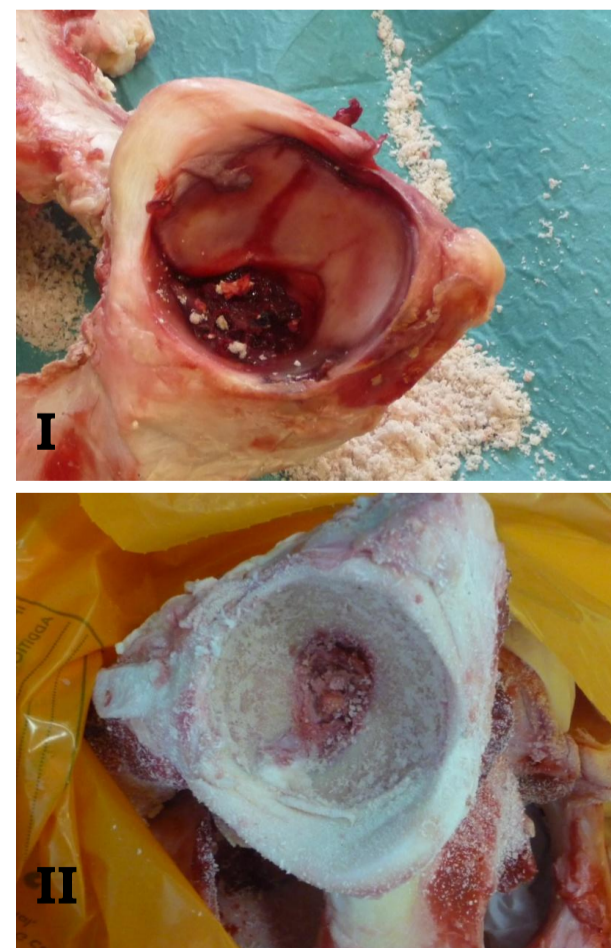
Figure 3 - Bovine Hemi-pelvis Before (I) and after (II) reaming

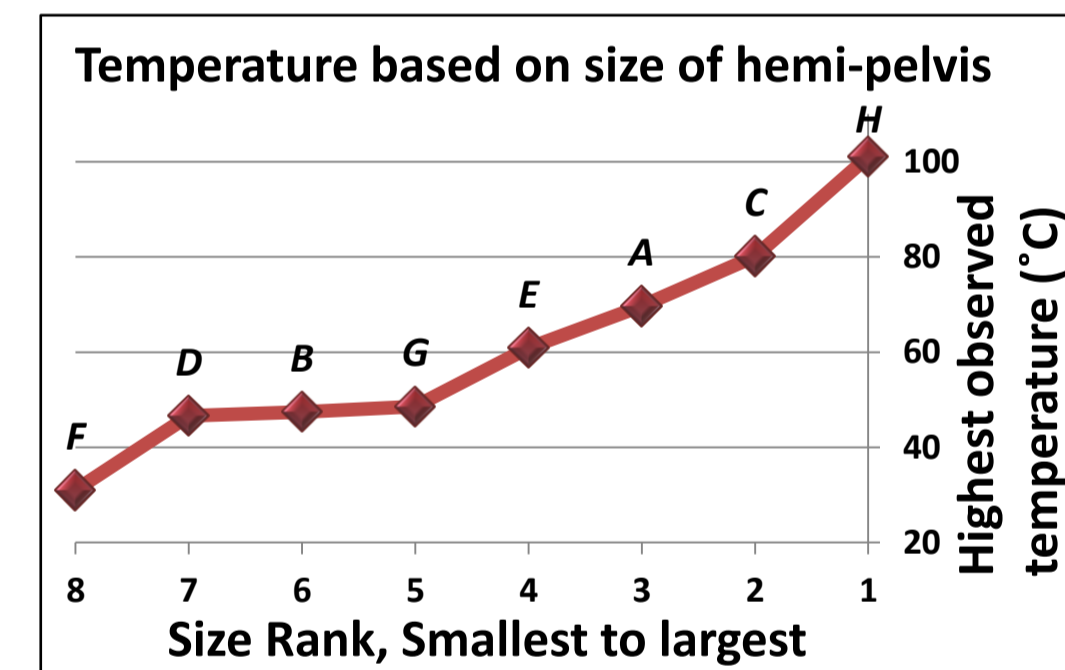
Figure 6 - Relationship between size of the hemi-pelvis and highest observed temperature

As shown in table 3 and figure 6, a direct relationship was found between bone size and observed maximum temperature.
