H31B-01

Morphological changes in a braided river of the Italian Alps during the last two centuries and related dynamics of riparian vegetation

Comiti Francesco¹, Da Canal Marco¹, Surian Nicola², Mao Luca¹, Mario A. Lenzi¹

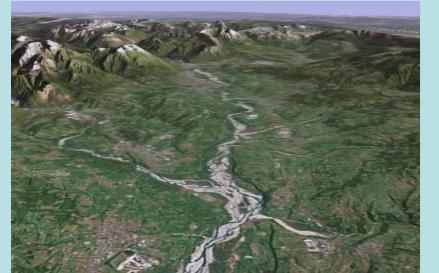
The valley of the Piave river in the study section, from downstream. The river corridor constrained by post-glacial fluvial terraces and, to a lesser extent, directly by hillslopes..

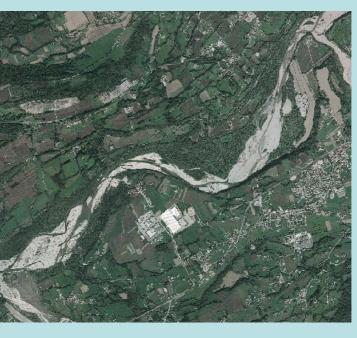
Sub-reaches 4-5. From left: 1805, 1926 and 2003
