Post-Eruption Recovery in Southern Chile

BSc Geography, BSc Physical Geography

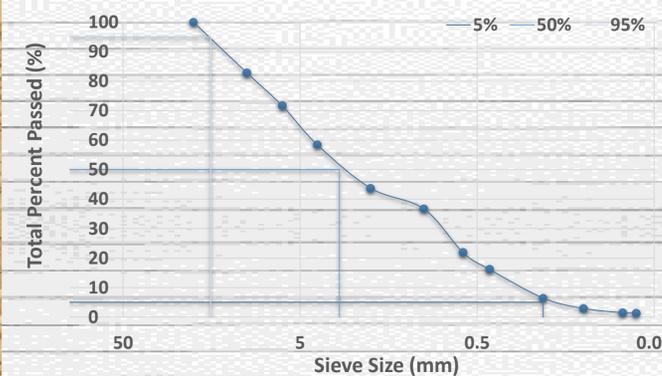
Figure 2: Grain-size distribution curve taken from the first stratigraphic column analysed

Figure 2 shows that less than 5% of sample 1 can be classified as silts (<0.0625mm), according to Wentworth's (1922) class sizes. The majority of the sample consists of sands, granules and pebbles.

- The Río Blanco Este cannot return to its pre-eruptive state due to excessive geomorphic change since April 2015
- Sand, granules and pebbles dominate the majority of sediment within stratigraphic columns at both sites
- Greater vegetation loss at the upper site due to the proximity of the vegetation to the eruption and river

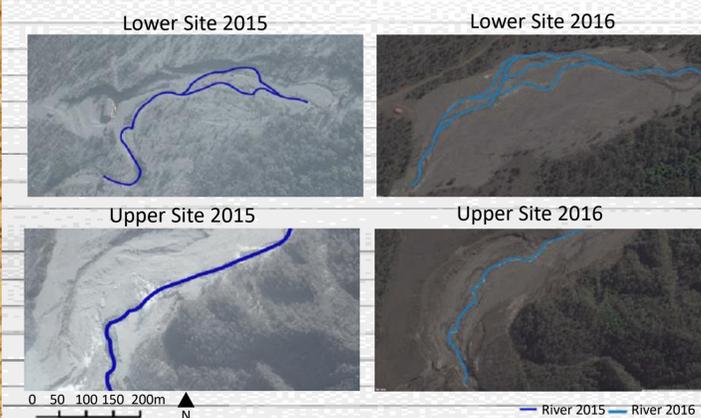
Figure 3: A comparison of the impacts of the eruption using aerial imagery on QGIS.

Figure 3 shows that more vegetation was closer to the river at the upper site pre-eruption, therefore more vegetation loss has occurred at this site since 2015. Both sites featured extensive lateral erosion of the Río Blanco, up to 121m at the lower site.
