Tyne Rivers Trust

Haltwhistle Burn – a comprehensive catchment approach to headwater runoff and pollution

Technical Report of the 2012-2015 Catchment Restoration Fund project, Defra

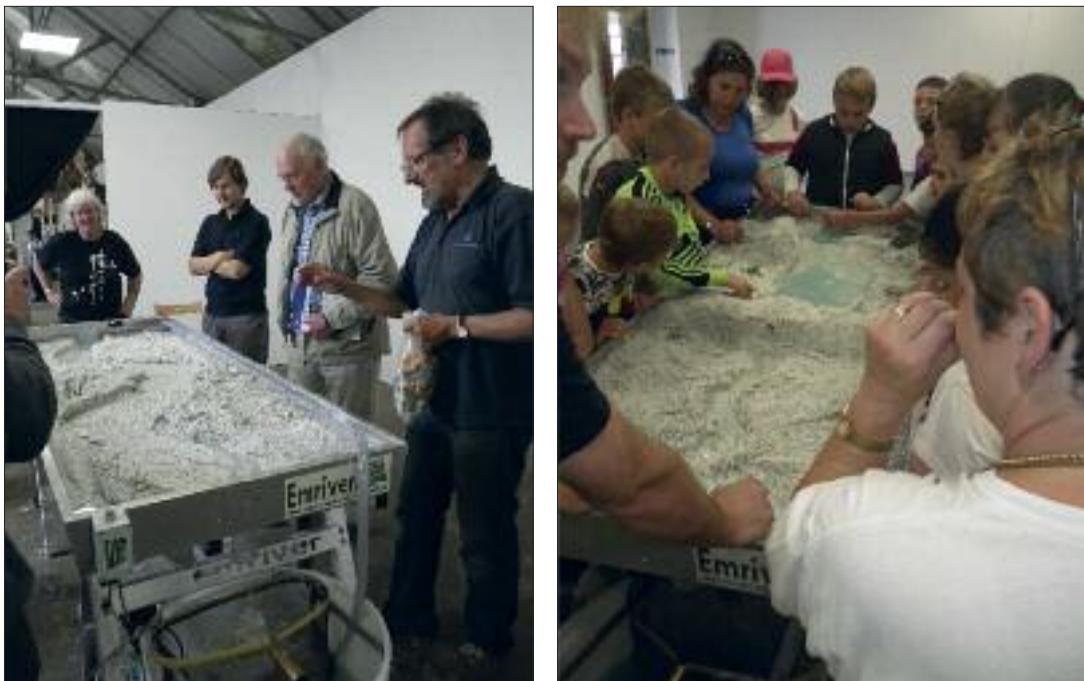
Fig 1.3.1 Using the Em River to explore and better understand river processes and to recreate Greenlee Lough

One way in which we have demonstrated some of the principles and processes of fluvial geomorphology in the CRF Haltwhistle Burn project is via the 'Em River' portable flume tank in which a model 'river', with variable flow, transports sediments to create channel forms.

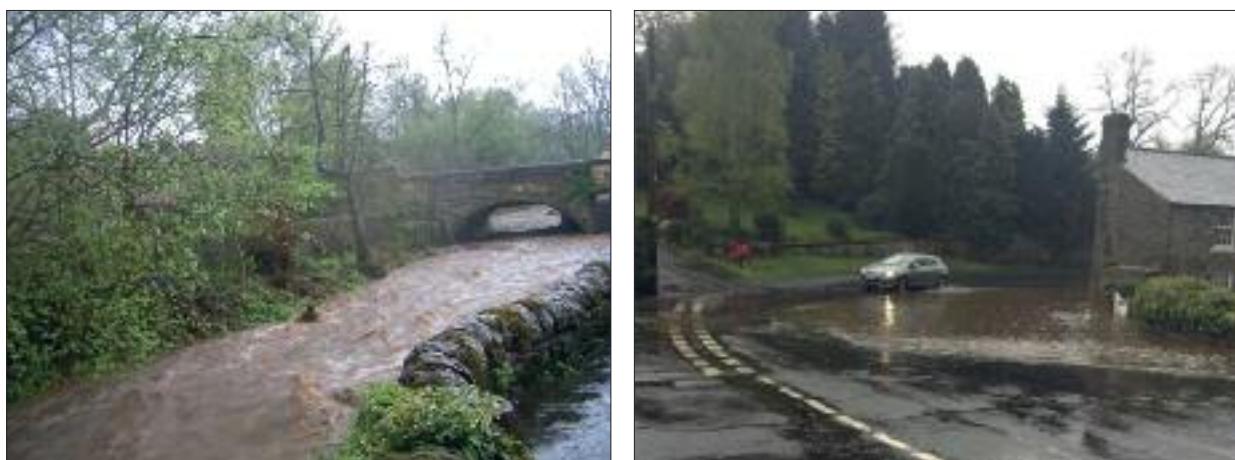
Figure 1.4.2 Catchment response during 30th April 2014 heavy rainfall events. (Images provided by the community).

equipment. With support from Newcastle University, we now have a network of automated equipment and 'River Watchers' (volunteers) which harvest a wealth of information. Recent 'cloud bursts' were therefore characterised, including the 30th April, 10th -11th May and 8th August 2014 events. Information collected has highlighted how extremely localised heavy rainfall events are across this small catchment. For instance, on the 30th April a member of the community manually measured 41mm of rain in their Town Foot garden which was reported to have fallen within just a 40 minute period. A local resident commented that "the floods had been and gone within a few hours" and Northumberland County Council confirmed that they did not have any reports of flooding elsewhere in the country that day. River levels shot up immediately (figure 1.4.1) and returned back to normal conditions within 24- 48 hours. Evidence of fluvial and pluvial flooding within the town was captured by the River Watchers (examples in figure 1.4.2).

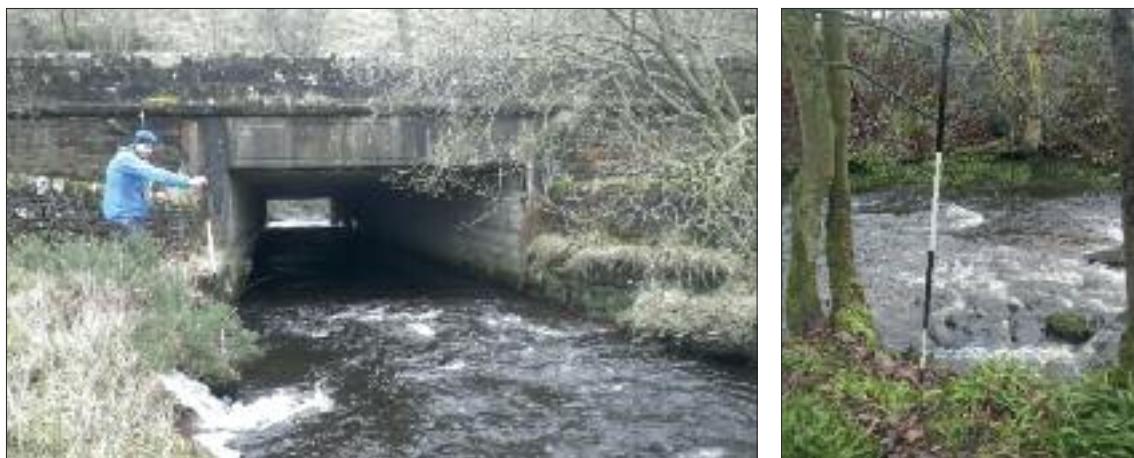
Figure 2.2.1 Measuring a culvert (left) and recording a check point site (right) for the River Habitat Survey.

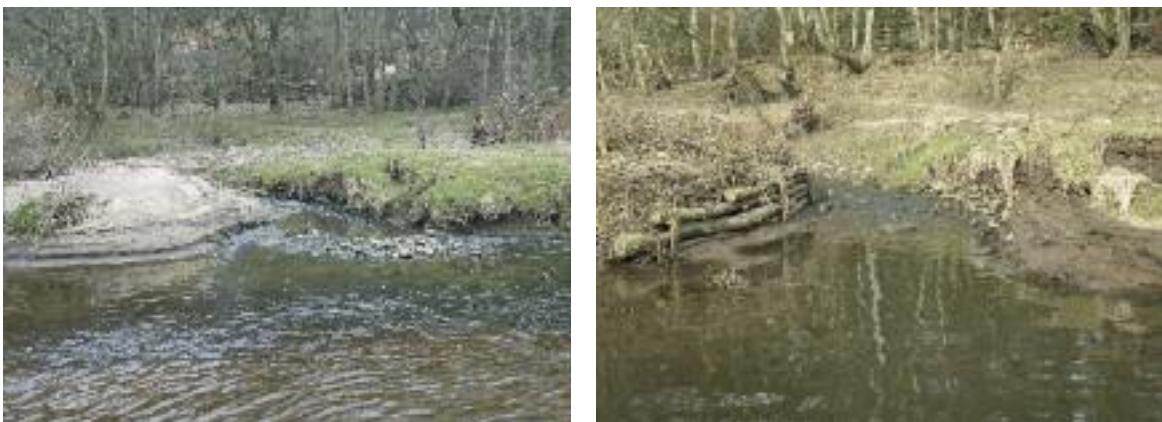
Fig 3.1.1 Haltwhistle burn mouth before and after simple green-engineered interventions

At the 'new' downstream mouth of the Haltwhistle burn locally cut wood was used to hold back silt and gravels keeping the channel open to allow fish passage up and STW consented effluent out. This also saves the land owner a lot of repeated effort in digging the channel by hand to prevent a stagnant pool developing.

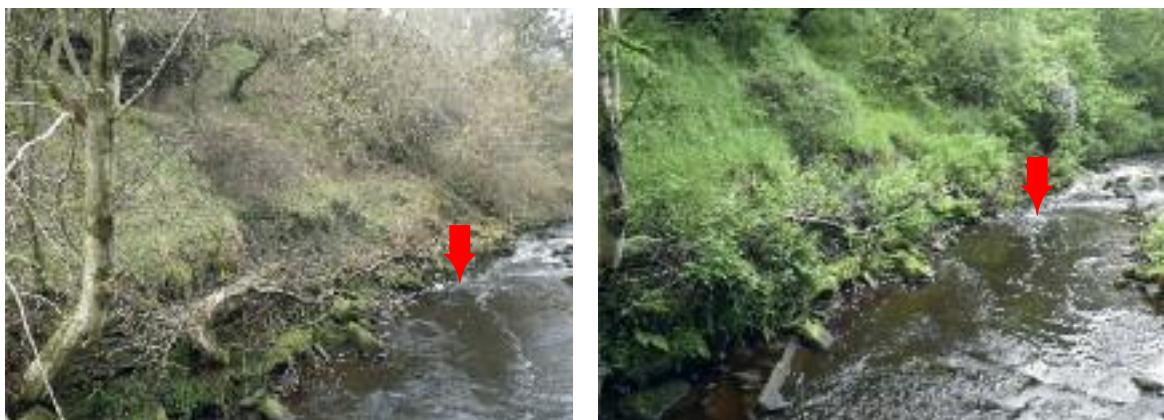
Fig 3.1.2 Living tree is laid to reduce river bank collapse at old quarry / mine site. Additional trunk is secured on the river bed to direct flow away from eroding bank. One season of growth demonstrates how well the bank is repairing. This is a fixed point photography site (from marked post on footbridge).

Further up the burn in the 'Gorge' section, trees have grown overly tall in search of sunlight. Many are at danger of collapse and taking out large volumes of the river bank. Some are ideally positioned, if laid like a hedge, to protect the water course from land slippage of contaminated sediment. Green-engineering techniques have been improved / enhanced in this rapid response catchment to build confidence from statutory agencies and local residents.

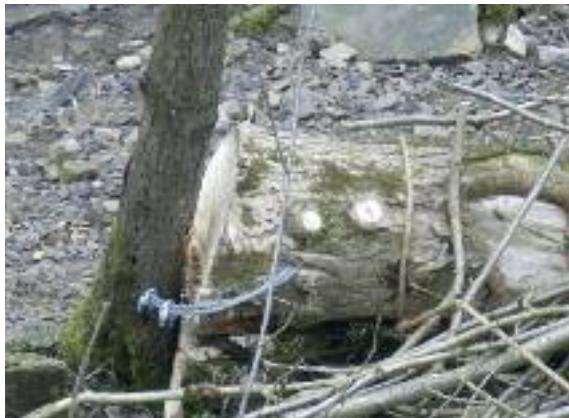
Fig 3.1.3 Usual hemp rope which will degrade in time as the trunk / brash bed into position is augmented by 6mm tensile cable threaded through live growing tree and felled trunk to ensure trunk does not detach in high flows and cause damage downstream.

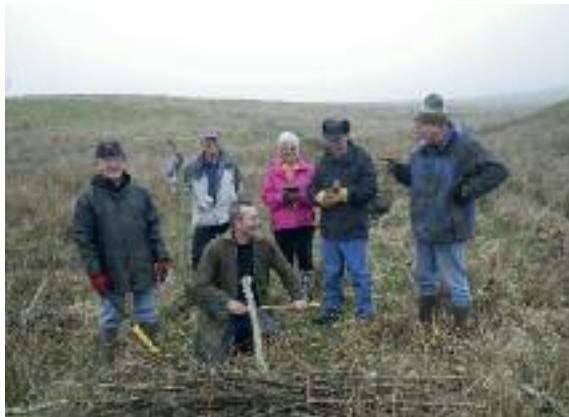
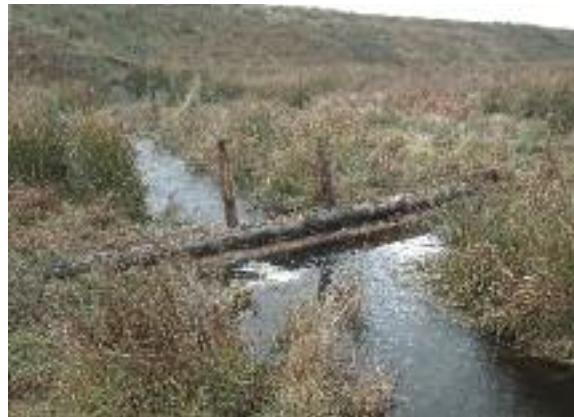
Fig 3.1.4 Volunteers working as a team (left) to produce brash bundles to add to the timber sluice constructions (right). Brash material was acquired from Environment Agency tree maintenance work further down the catchment and transported to site by a project partner.

In the head waters simple timber sluices and secured brash bundles take the power out of the water in storm conditions, pushing sediment onto the floodplain. These forms of interventions are easily installed and maintained by trained volunteers.

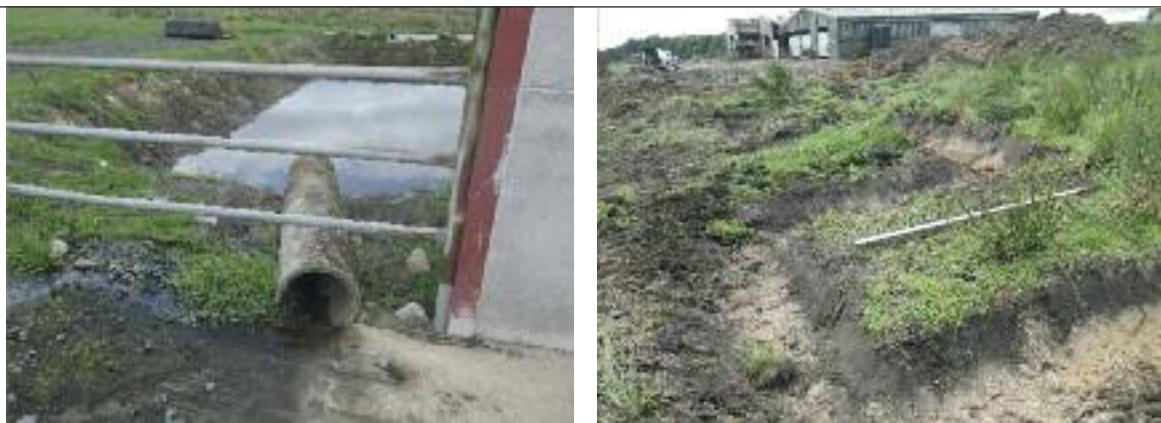
Figure 3.2.1 First settlement pond, also showing access track for emptying the pond, reinforced wall and stock proof fencing (left). Winding settlement channel with first settlement pond, farm buildings with guttering and water tanks in the back ground (right).

It is worth noting here that the guttering work was carried out by the farmer as in-kind contribution and that the contractors completed the wetland creation work within 2 working weeks. Most of the time and effort is spent in engaging with land owners and statutory bodies. To create the most appropriate and resilient solution it is important to fully understand the farm as a business, the environmental considerations and any history. During construction of the wetland and since 'completion' the work has been re-evaluated and adapted to suit discoveries made. For example additional reinforcement of the settlement pond wall was added to better withstand the strong prevailing westerly winds at this site and the first channel receiving overflow water from the settlement tank has been re-sculpted to better deal with any potential jetting from the inlet pipe.

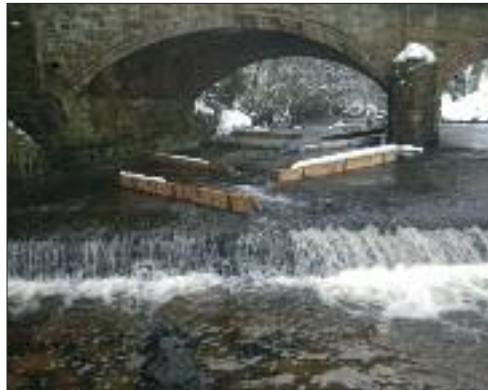
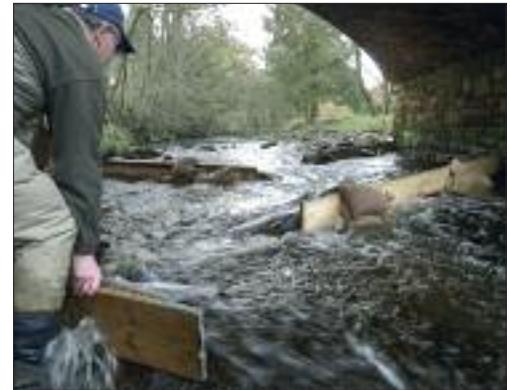
Stocksfield Ford and Juniper Bridge

Tyne Rivers Trust has been designing and building low cost fish passage easements since 2009. To date we have mapped dozens of obstructions and engineered better fish passage at 9 Sites. We have developed techniques to suit a range of river obstructions and these active experiments have informed the most recent works at Haltwhistle.

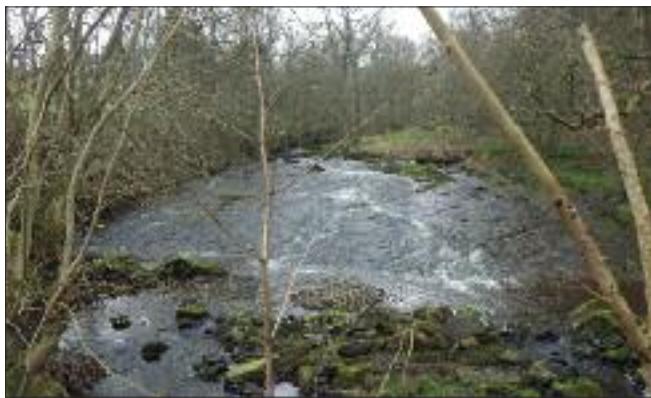
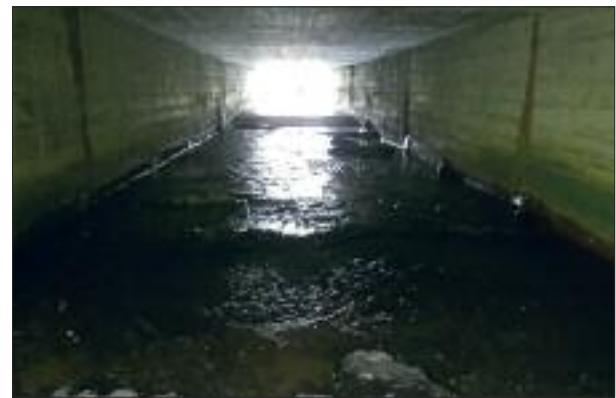
There are two major in river obstructions on the Halty Burn, Mossy Banks and Military Road Bridge Footings. These two obstructions are very different and had a combined negative effect on fish migration in this upland catchment. Environment Agency monitoring of fish stocks had discovered lower than expected fish abundances in the Halty Burn. TRT's own electrofishing surveys confirmed this situation, but only in the upper reaches of the river. It appears that the fish populations are very sparse above, but abundant below these obstructions. This situation is likely to be due in part to the effect of these obstructions. The Mossy Banks obstruction is a former industrial mill site. The channel has been constrained with embankments on both sides of the river and a stone weir remains across the burn. Now that the mill is gone, the river bed is a wide, long and steep bedrock plain. The flow is often shallow, giving all fish species a major challenge and often leading to an aggregation of waiting fish which are susceptible to disease and poaching. The Military Road Bridge Footings are the next major and most upstream Halty impasse. A concrete stepped culvert at almost 50m long with shallow Summer and raging Winter flows, presenting difficulties for resident and migratory fish alike.

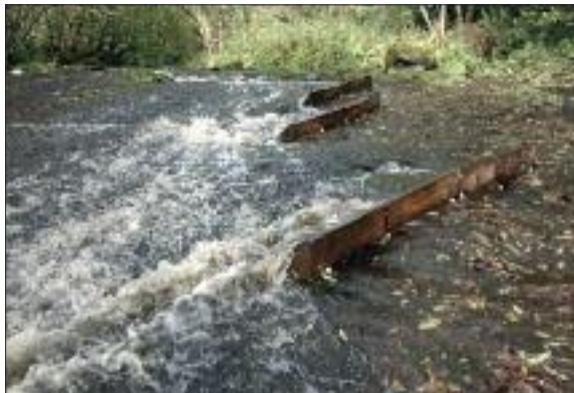
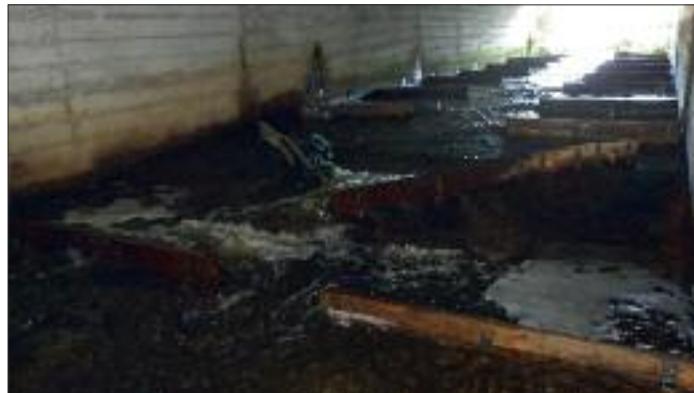
We worked in a downstream direction so that we were able to see the effect we were having of river flow as we fixed our wooden baulks. This adaptive design and management is a very good way of avoiding unforeseen outcomes as it is difficult to model the effect of water with so many variables in play. TRT are very fortunate to be advised by our experienced fisheries consultant Aidan Pollard. Aidan has a unique skill set which has provided insight into fish behaviour. This experience has led us to designs with multiple access points and resting places so that all fish can vary their attempts according to river flows.

We are careful to consider the wider implications of our simple fish easements in relation to flood risk, damage to infrastructure, maintenance and effects upon ecology. We also design our baulk fixings so that these individual blocks can be modified or removed simply should it be required.

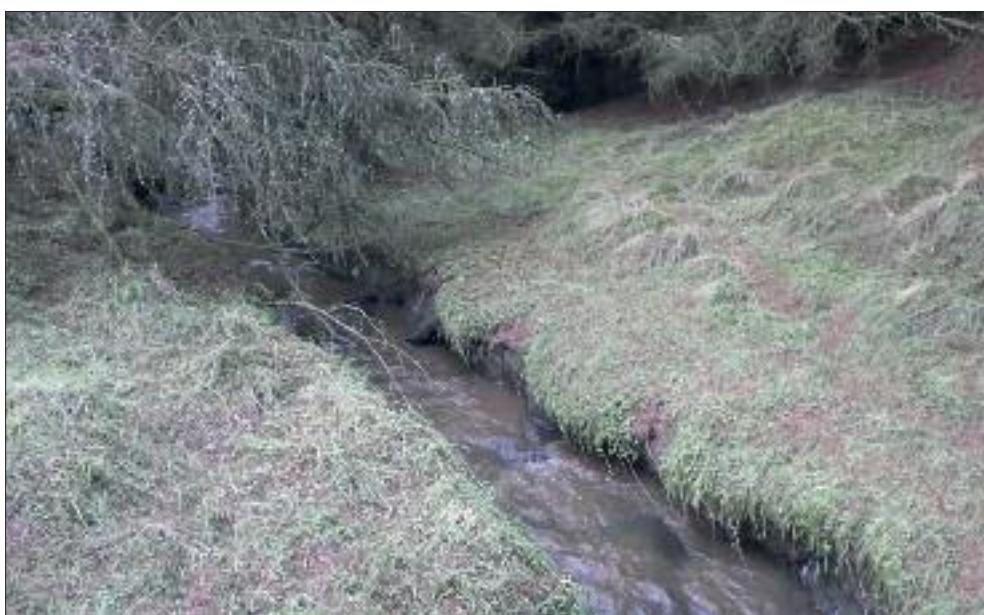
Sediment load in Haughtongreen Burn in Haltwhistle Burn catchment below the connected drains
