# Observations from the 26th November 2019 Albania earthquake: the earthquake engineering field investigation team (EEFIT) mission

Fabio Freddi<sup>1</sup> · Viviana Novelli<sup>2</sup> · Roberto Gentile<sup>1,3</sup> · Enes Veliu<sup>4</sup> · Stoyan Andreev<sup>5</sup> · Anton Andonov<sup>5</sup> · Federica Greco<sup>6</sup> · Emiljano Zhuleku<sup>7</sup>

## Abstract

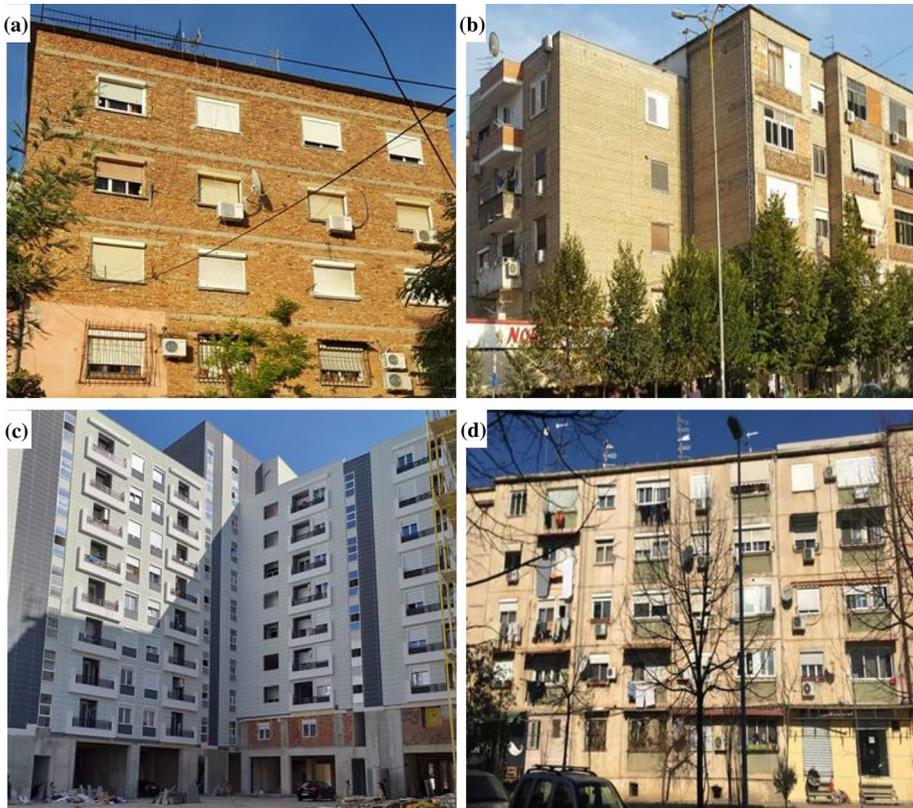
**Fig. 5** Representative typologies of the multi-storey Albanian building stock: **a** unreinforced masonry building (URM) in clay bricks; **b** confined masonry (CM) building in silicate bricks; **c** new reinforced concrete (RC) building (under construction); **d** prefabricated large-panel building

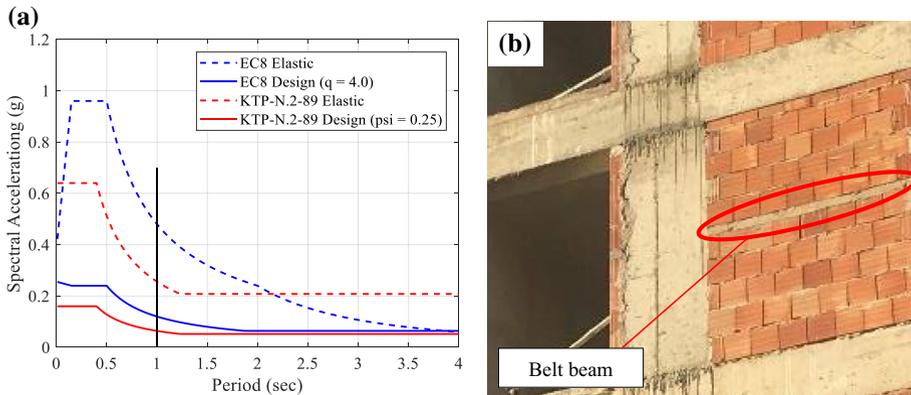
1. The strength requirements of the KTP-N.2-89 are lower than those of the Eurocode 8. Figure 11a shows a comparison of both the elastic and design spectra defined according to the KTP-N.2-89 and Eurocode 8. The example refers to a structure located in an area with  $PGA = 0.32$  g, soil category Type II, response factor  $\psi = 0.25$  (corresponding to a behaviour factor  $q = 4$  in EC8) and a fundamental period  $T_1 = 1.0$  s. The corresponding design spectral acceleration are equal to  $S_a(T_1) = 0.064$  g for the KTP-N.2-89 and  $S_a(T_1) = 0.12$  g for the Eurocode 8;

**Fig. 11** **a** Comparison of the elastic and design spectra for one representative site according to the KTP-N.2-89 and the Eurocode 8; **b** belt beam for infill panels in Typical 2010+ multi-storey RC buildings

3. Absence of stiffness requirements i.e., no considerations regarding Damage Limit State (DLS) checks. This aspect could be considered the most evident difference between the KTP-N.2-89 and the Eurocode 8 and is the main one that, in this occasion, affected the seismic response of multi-storey RC buildings. This aspect shows that insufficient consideration is made to the damage of the building under low-intensity (i.e., frequent) earthquakes, which is generally concentrated in the infill panels (for the considered building typology). However, attention is paid to the out-of-plane behaviour of the infills by the introduction of belt beams as shown in Fig. 11b.

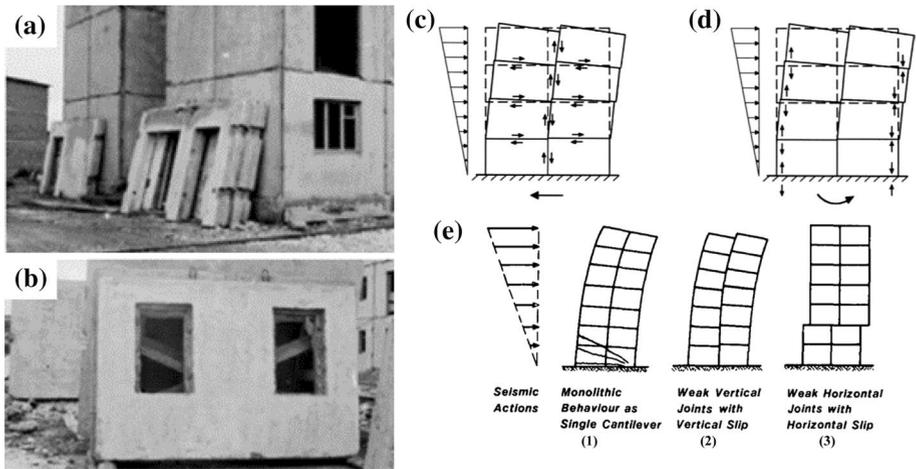
**Fig. 16** **a** and **b** Large-panel buildings in Albania; **c** in-plane shear forces of prefabricated wall; **d** in-plane tensile and compressive forces of prefabricated wall. **e** Different behaviours and possible failure modalities. Based on Abazaj (2019), fib Bulletin 43 2008 and UNDP/UNIDO 1985

have monolithic behaviour under lateral load as shown in Fig. 16e, and the structural damage will be concentrated in the form of diagonal cracks in the panels. However, in prefabricated concrete wall systems there may be significant slip (shear displacements) along the vertical and horizontal joints. Figure 16e also shows horizontal actions applied to a large-panel cantilever wall in which slip has occurred along both vertical and horizontal joints due to shear forces transferred along these joints. The effect of slip along the horizontal and vertical joints is to reduce the stiffness of the system. It is difficult to say which will be the prevailing seismic response and failure mode of large-panel walls under earthquake loads. The observations in past earthquakes in Romania, Armenia and Bulgaria suggest that slippage between panels is likely to occur since most of the reported damage was in the form of horizontal and vertical cracks in the interfaces between panels. This situation with ‘strong panels—weak joints’ is also related to the high-quality control of the prefabricated elements which provides the prefabricated panels with a high concrete resistance. However, the situation with ‘strong joints—weak panels’ cannot be excluded and should be checked during the assessment procedures. In addition, in the most common situations with ‘strong panels—weak joints’, the slippage and rocking between panels, is likely to provide a significant friction damping which is beneficial for the seismic performance of these structures and could be one of the reasons for the good seismic performance of large-panel buildings observed in past earthquakes.

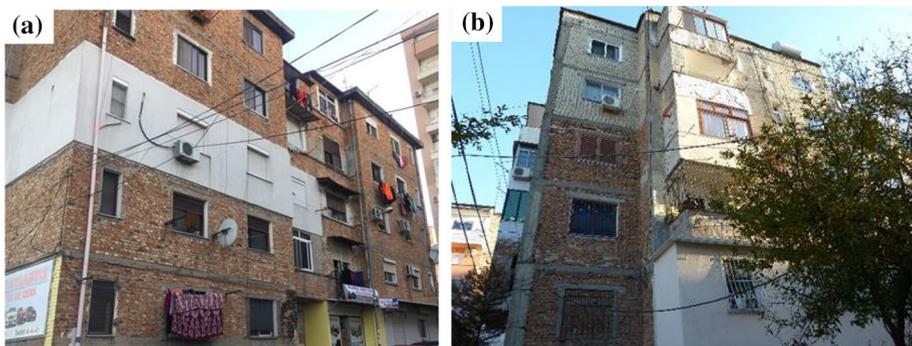
**Fig. 17** Typical 5-storey **a** unreinforced masonry (URM); **b** concrete-masonry (CM) buildings in Durrës

The major deficiencies observed for these buildings are related to irregularities in elevations due to unauthorised interventions such as the closure and creation of new openings, use of different masonry for reparation, and introduction of additional floors carried out by the owners of the single dwellings as showed respectively in Fig. 19a–c. These alterations, together with the lack of maintenance, degradation of the mechanical properties of the material, and change of the load paths, can become the origin of damage and deteriorations, which may increase the seismic vulnerability of the structure over its lifetime.

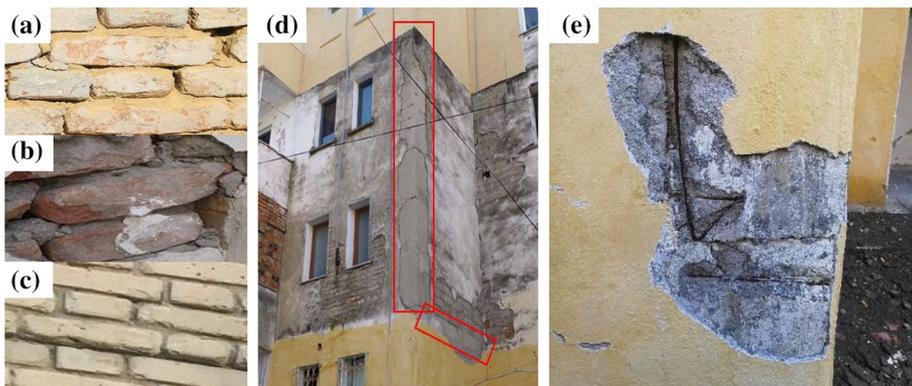
the CM buildings (see Fig. 18d, e) consist of RC columns with typical cross section of  $380 \times 380$  mm and RC beams with depth of 250 mm or 380 mm, depending on the wall thickness at their locations. The concrete class is typically C16, or lower, while the typical steel grade is S220 (Bilgin and Korini 2012).

**Fig. 18** Typical bricks for load bearing walls. Solid clay bricks with **a** silicate mortar, **b** cement mortar, and **c** silicate bricks with silicate mortar. Details of concrete-masonry (CM) buildings, **d** reinforced concrete columns and beams, **e** reinforcements

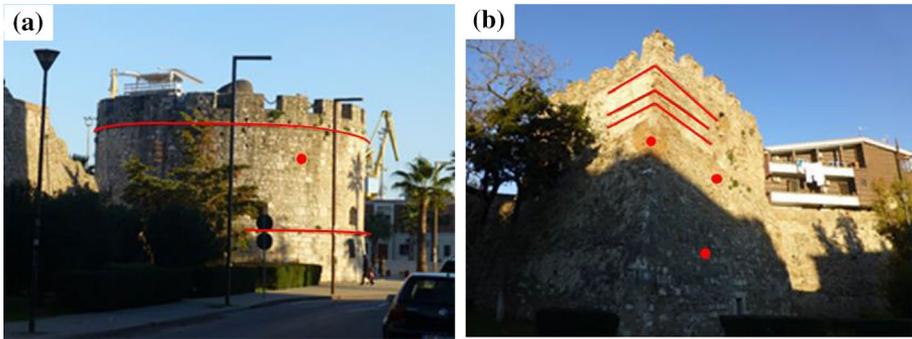
**Fig. 22** Visible repairs of the towers of Durrës: **a** Venetian tower; **b** gate tower
